LETTER REPORT  
FOR  
SANDOVAL ZINC  
SANDOVAL, MARION COUNTY, ILLINOIS  
TDD: T05-9111-010  
PAN: EIL0760DAA

MARCH 13, 1992

RE: Sandoval Zinc site  
Sandoval, Marion County, Illinois  
TDD # T05-9110-025  
PAN # EIL0760DAA

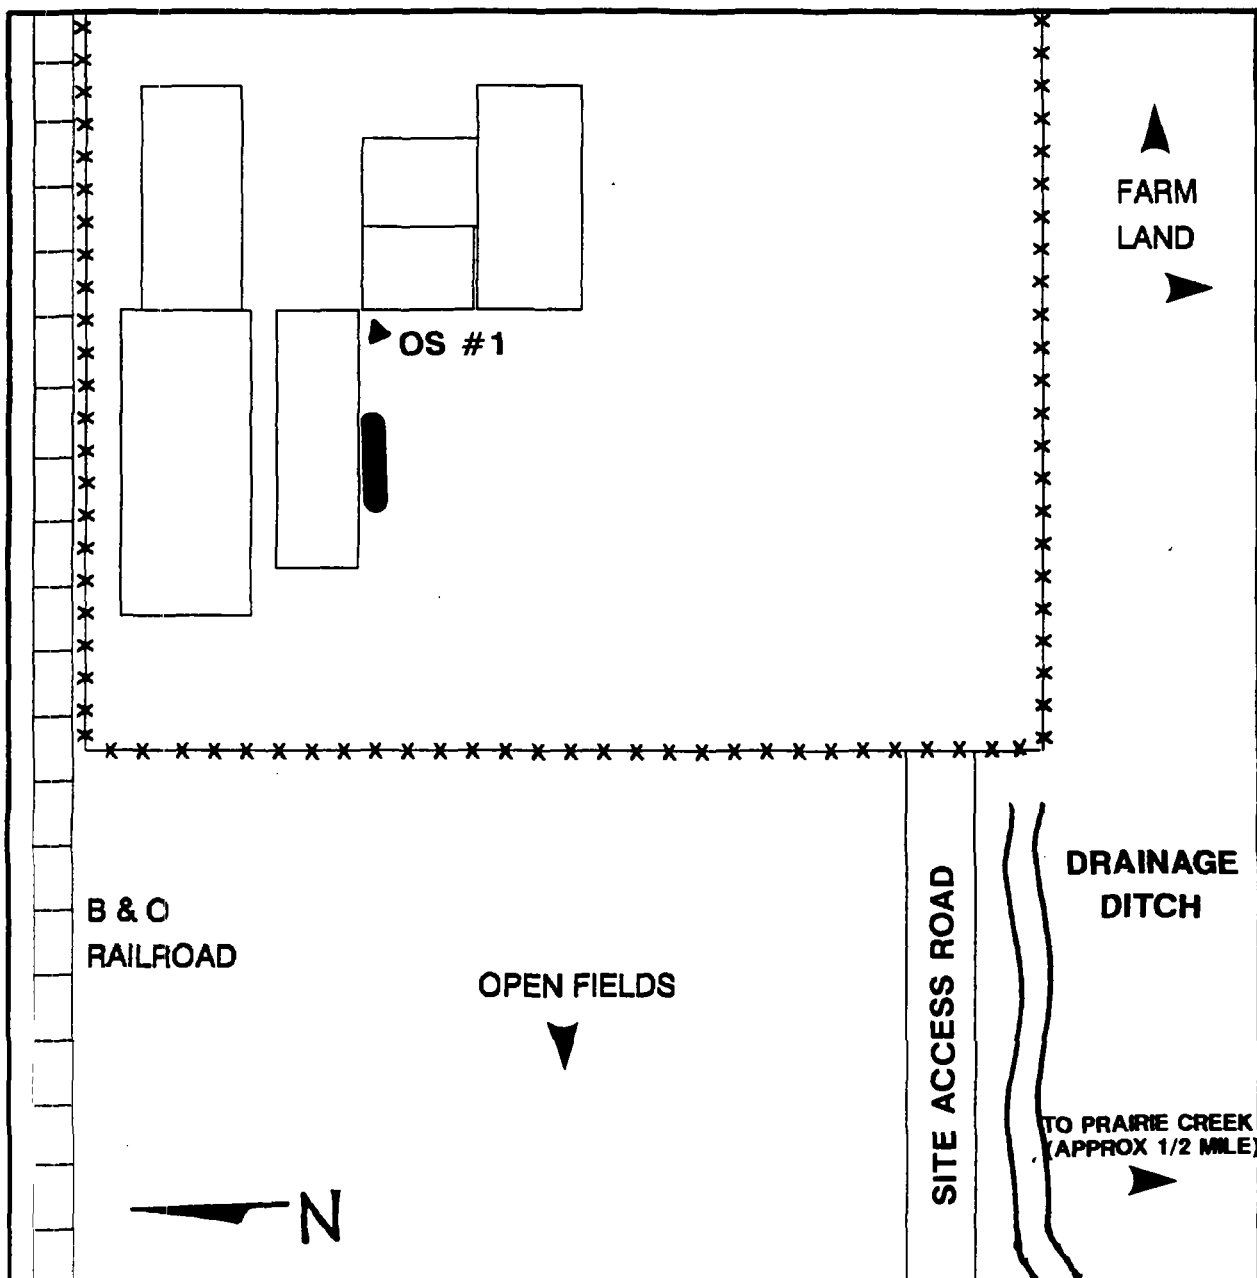
<b>LEGEND</b> = OIL STORAGE TANK  = SITE BOUNDARY  = OIL SAMPLE #1	<b>ecology and environment, Inc.</b> <b>Technical Assistance Team</b> <b>Region V</b> 111 W. Jackson Blvd, Chicago, IL 60604	
	TITLE <b>SAMPLE LOCATION</b>	FIGURE # <b>4</b>
	SITE <b>SANDOVAL ZINC</b>	SCALE <b>NOT TO SCALE</b>
	CITY <b>SANDOVAL</b>	STATE <b>IL</b>
	SOURCE <b>ON-SITE OBSERVATIONS</b>	PAN <b>EIL0760DAA</b> DATE <b>MARCH 92</b> REVISED
